# Application report – 42/Sinovel BRAZIL

## Sinovel SL 1500 wind turbine gearbox treatment

Report Date:	22.02.2018
Sector:	Wind power industry
Client/Partner:	Statkraft Energias Renováveis 88015-100-000 Florianópolis SC Brazil
Contractor:	REWITEC GmbH Dr.-Hans-Wilhelmi-Weg 1 35633 Lahnau - Germany Tel. +49 (0)6441 44599-0 Fax +49 (0)6441 44599-25
Responsible:	E. Michael König
Order date:	08.11.2017 and 09.0.1.2018
Wind farm location:	Barra dos Coqueiros SE
Wind farm:	Barra dos Coqueiros
Wind turbine type:	Sinovel SL 1500
Serial Nr.:	BC-03
Project tasks:	Surface improvement of gearbox gears and bearings. Application with REWITEC <sup>®</sup> DuraGear <sup>®</sup> W100 Gearbox Surface Protection, as well as detecting the state of the gear surfaces with the REWITEC <sup>®</sup> -Replica Set (Surface imprints).
Tasks:	<ul style="list-style-type: none"><li>➤ Change of the main filter</li><li>➤ Temporary switch off of the by-pass filter</li><li>➤ Surface treatment with REWITEC<sup>®</sup> DuraGear<sup>®</sup> W100</li></ul>

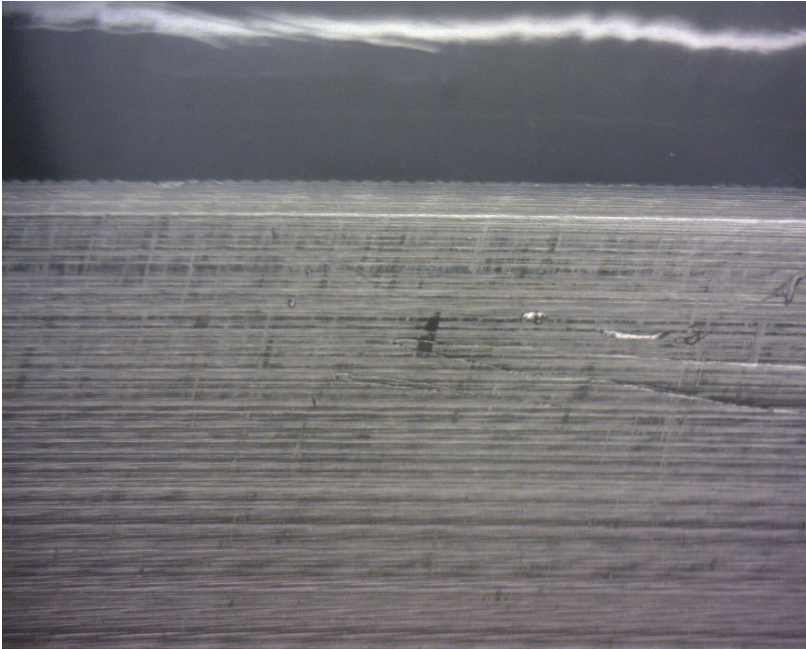
Image 8: BC-03 HSS before REWITEC<sup>®</sup> treatment on 8.11.2017

- Visible surface roughness
- Visible micropitting

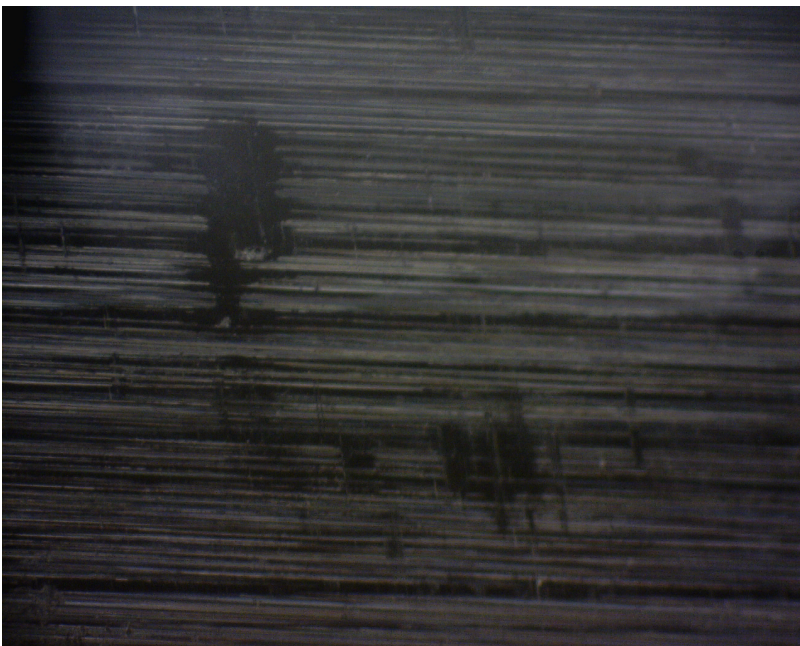
Image 9: BC-03 LSIS before REWITEC<sup>®</sup> surface treatment on 8.11.2017

- Pronounced surface roughness
- Evident pitting

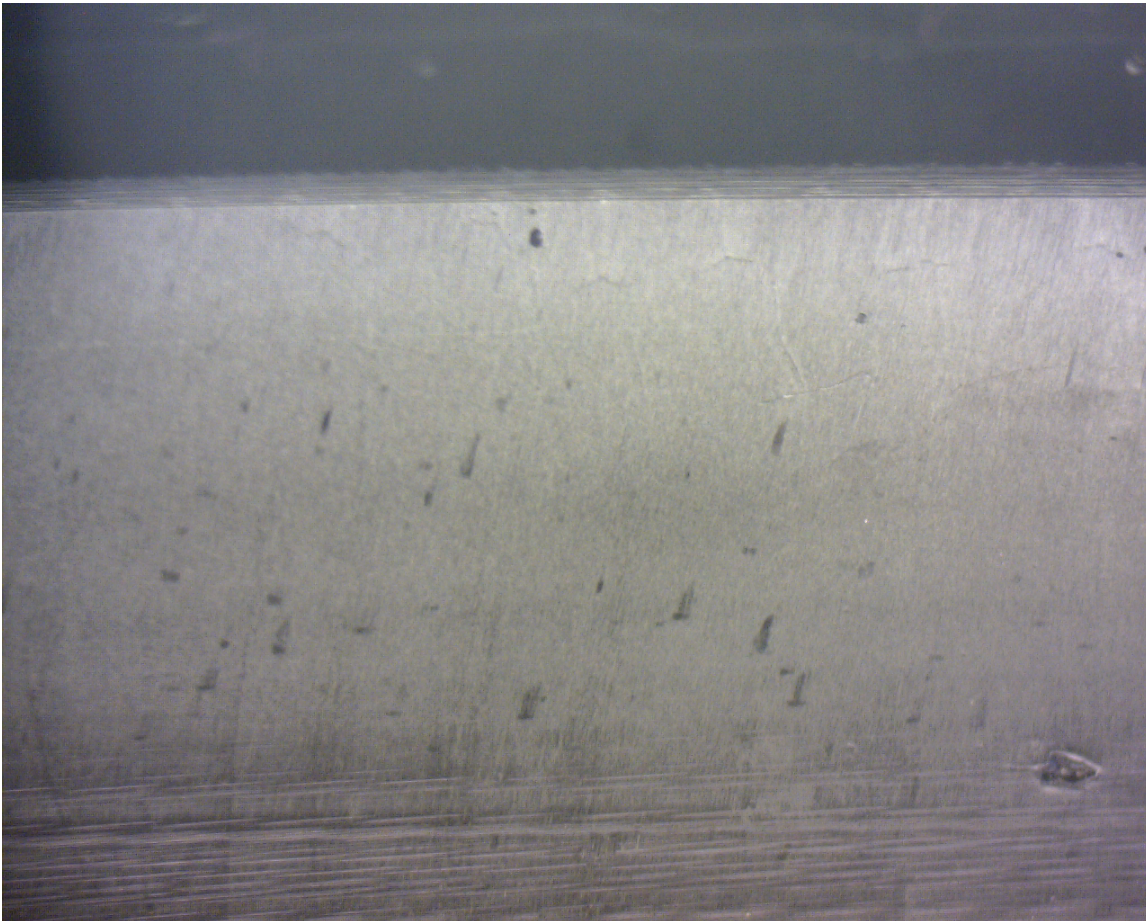
Image 10: Surface imprint of BC-03 HSS after the REWITEC<sup>®</sup> surface treatment on 09.01.2018

- ✓ Surface is visibly smoother
- ✓ Micropitting reduced or eliminated partially

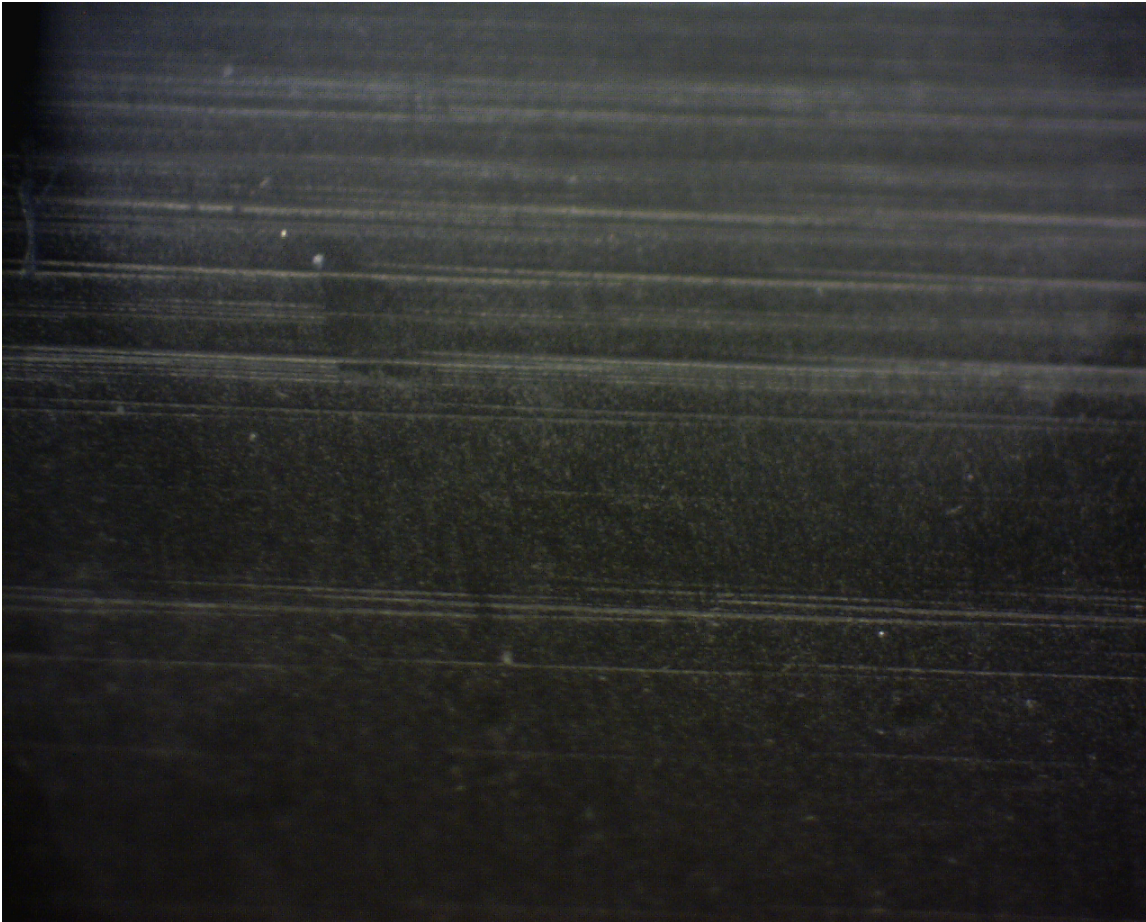
*Image 11: Surface imprint of BC-03 LSIS after the REWITEC<sup>®</sup> surface treatment on 09.01.2018*

- ✓ Improved surface appearance
- ✓ Evident pitting reduction

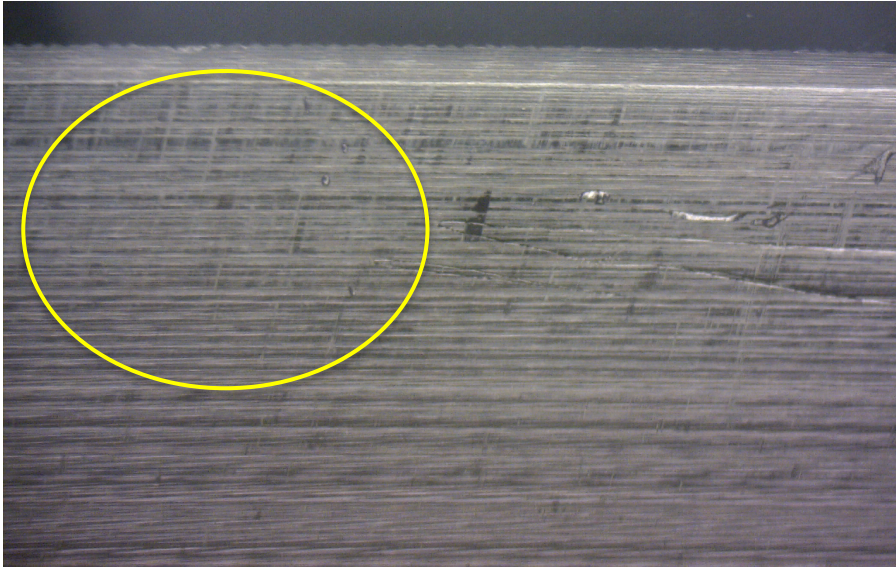
Image 9: BC-03 HSS before the REWITEC<sup>®</sup> surface treatment on 8.11.2017

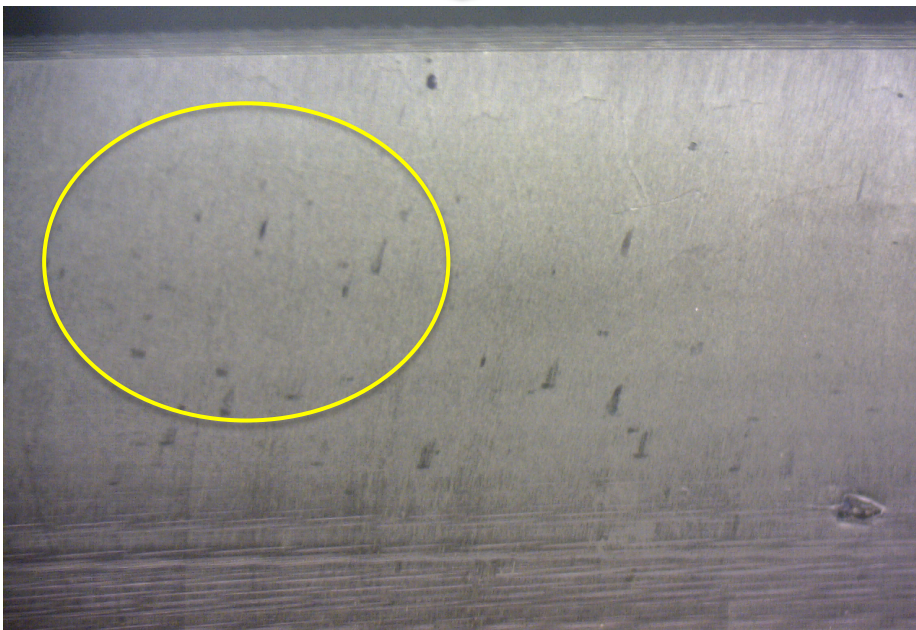
Image 10: BC-03 HSS after the REWITEC<sup>®</sup> surface treatment on 09.01.2018

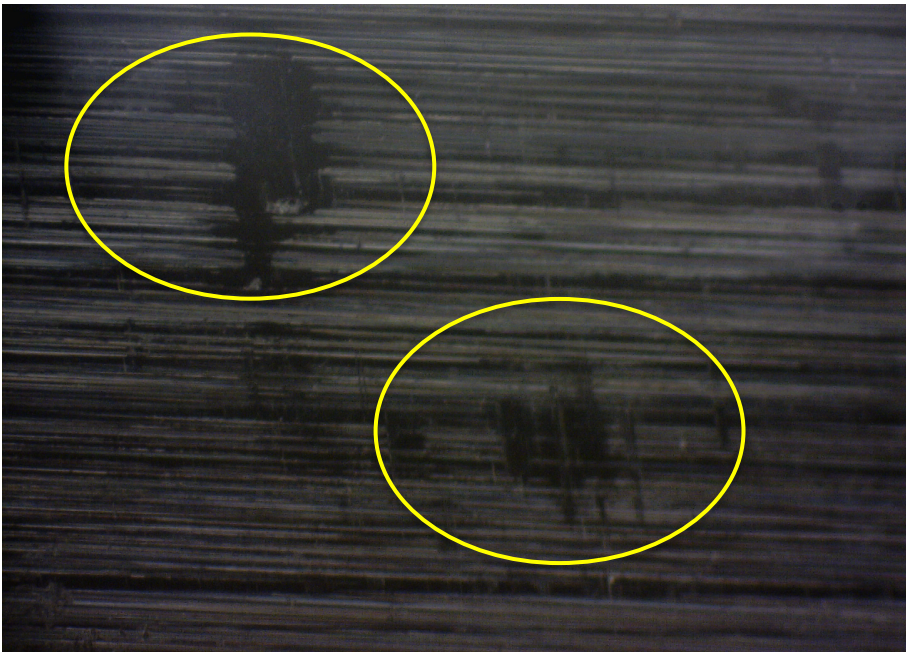
*Image 11:* BC-03 LSIS **before** the REWITEC<sup>®</sup> surface treatment on 8.11.2017

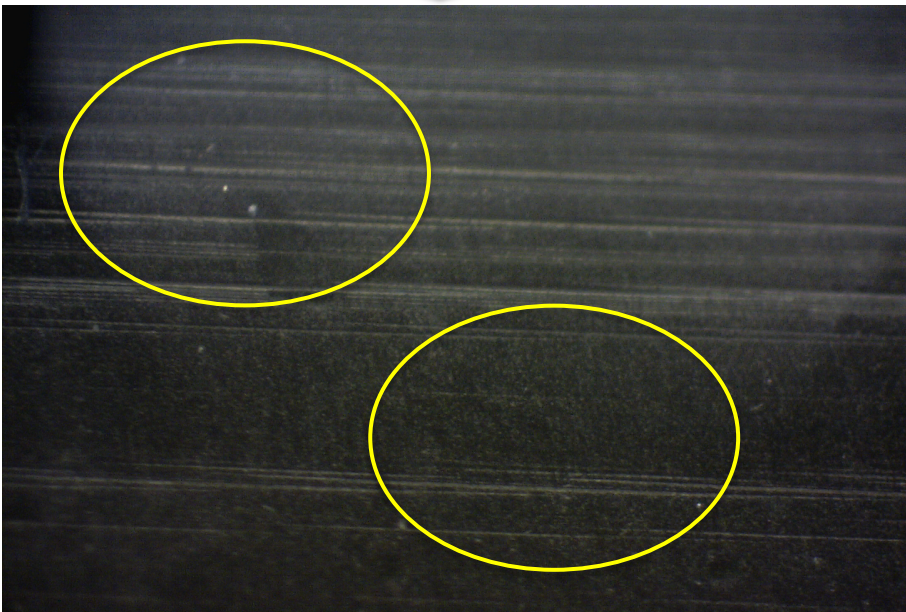
*Image 12:* BC-03 LSIS **after** the REWITEC<sup>®</sup> surface treatment on 09.01.2018

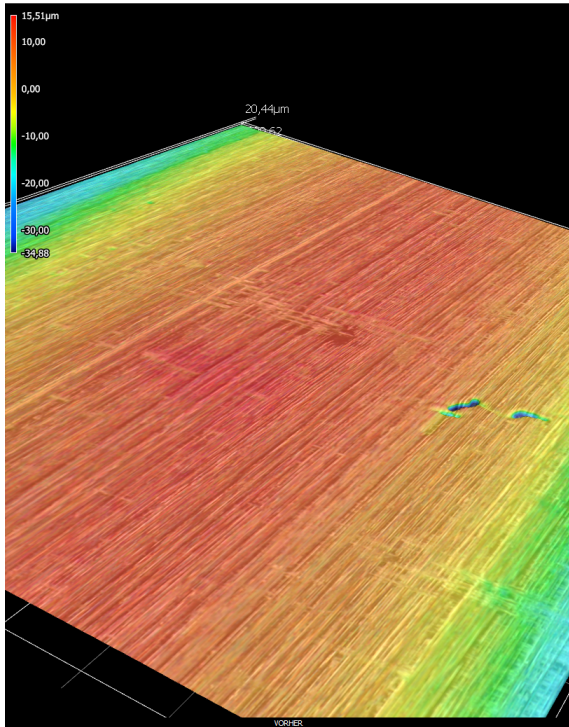
Image 13: surface of LSIS before on 08.11.2017

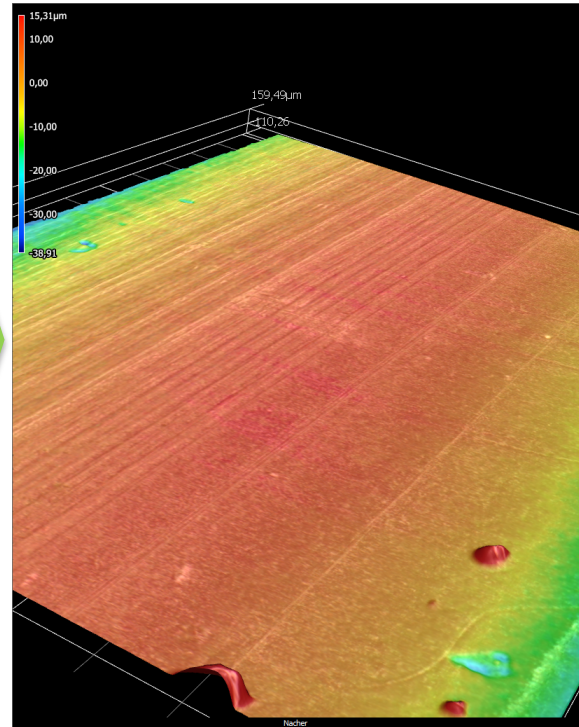
Image 14: surface of LSIS after on 09.01.2018

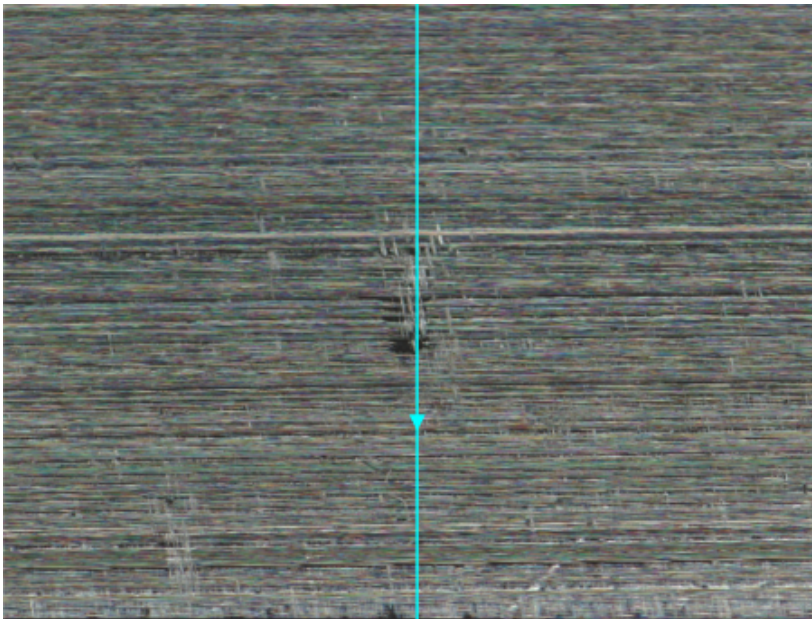
Nr.	Name Messung	Messwert	Einheit
1	Ra	0,66	µm
2	Rz	3,69	µm

Image 18: *before* surface treatment on 08.11.2017

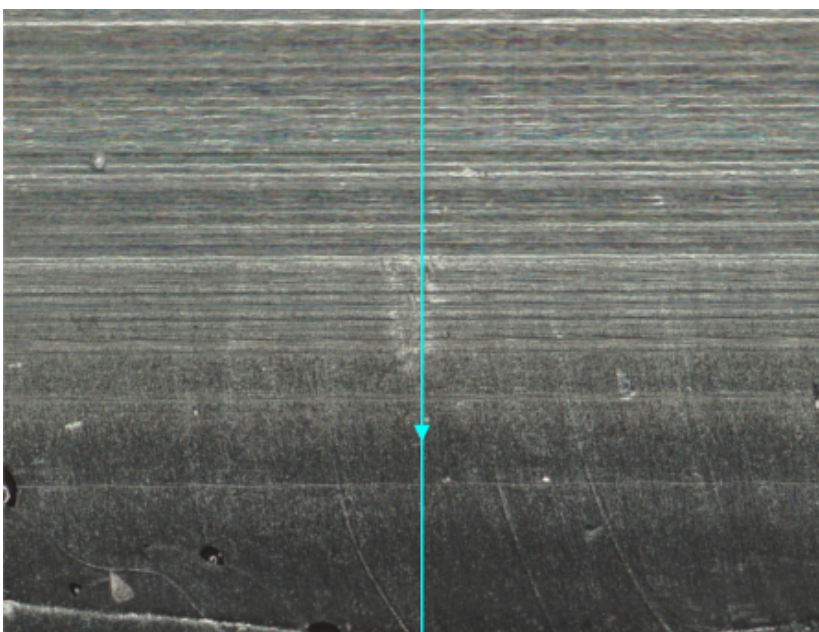
Nr.	Name Messung	Messwert	Einheit
1	Ra	0,52	µm
2	Rz	3,26	µm

Image 19: *after* surface treatment on 09.01.2018

✓ **Over 21 % of surface roughness improvement (Ra)**
