Jose Luis Hoyos
Service Manager
Availon Iberia

The case

- ▶ The gearbox is one of the most expensive components of the WTG. A damage of the gearbox leads to high costs and a long downtime of the WTG. Therefore, Availon was searching for an effective method to extend the lifetime of a gearbox. An innovative oil-additive finished the search of Availon.

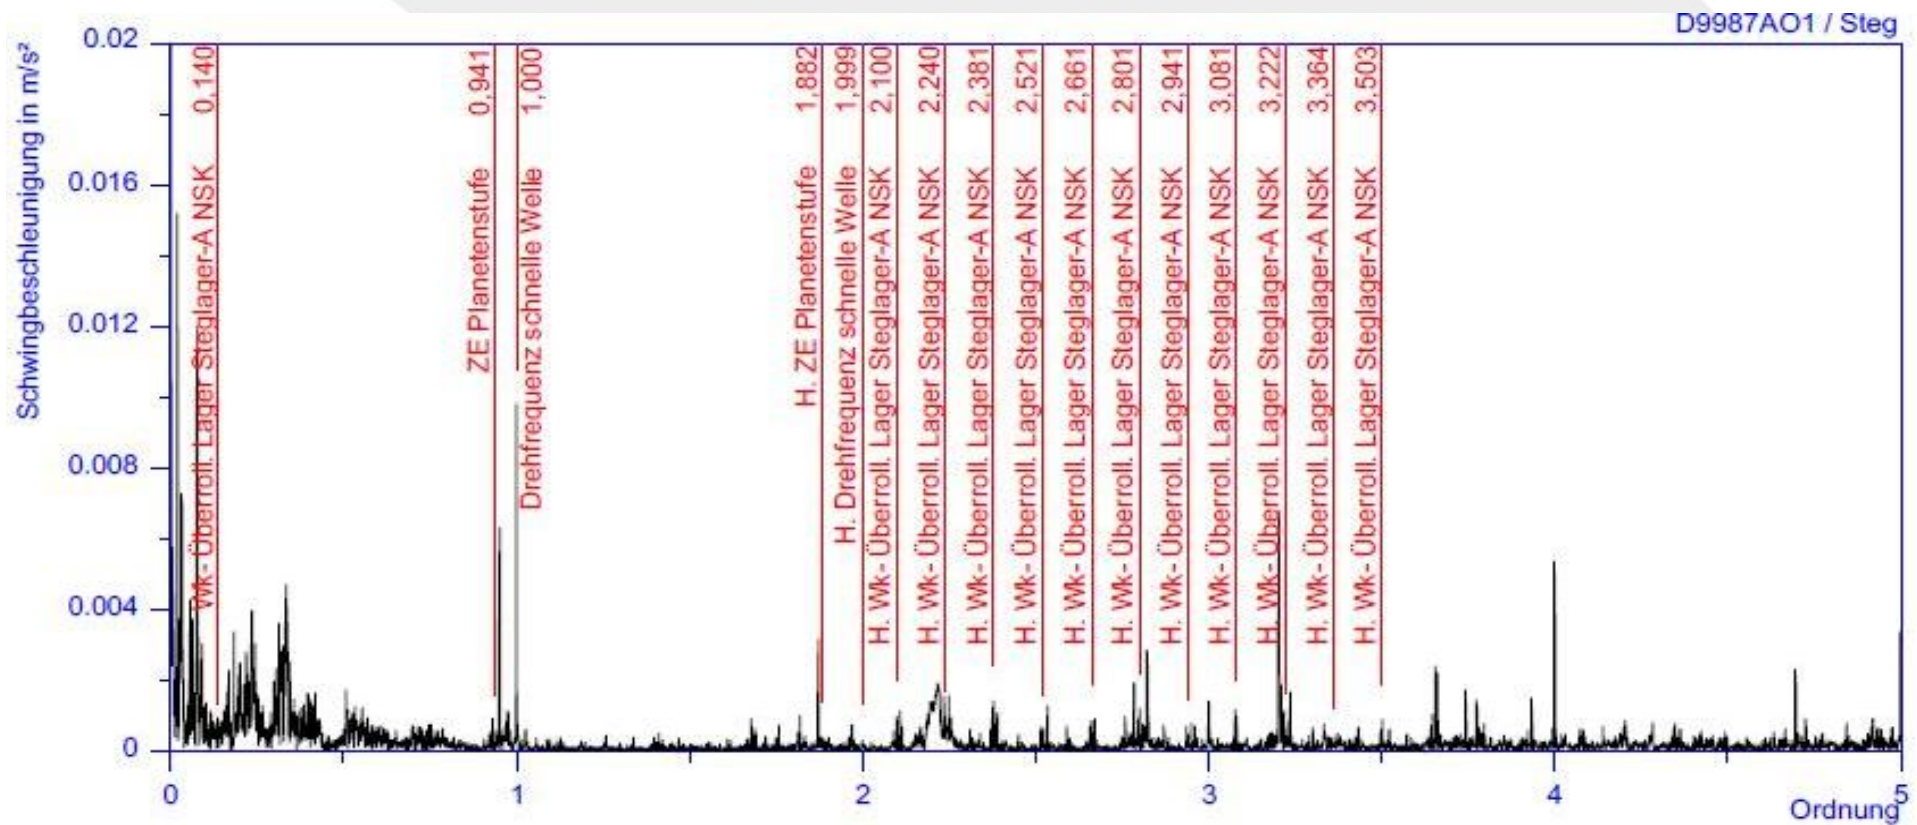
2012: The frequency result of the rolling elements

- There is a 50% possibility that the component will have a damage within a year

Overrollings
